ANNUAL REPORT

2008-2009

DRINKING WATER SUPPLY

MOUNT BULLER AND MOUNT STIRLING

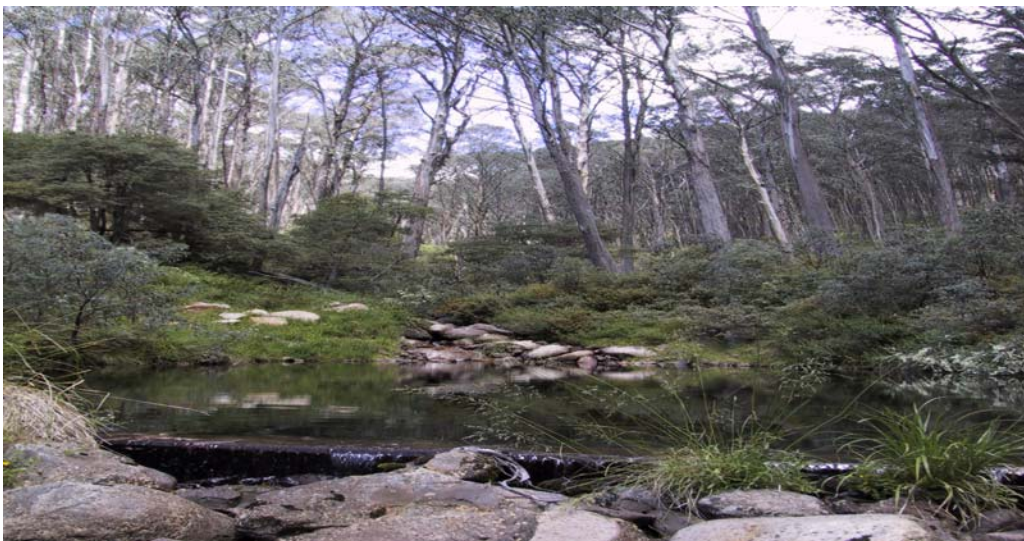
Figure 1 - Boggy Creek Catchment

Figure 1 gives a good indication of the nature of the catchment from which the Mount Buller Alpine Village drinking water is sourced. The topography is steep and vegetated. The catchment lies in montane, sub alpine and alpine areas. There are few weeds or other exotic flora. Fauna consists of wild dogs, deer, wombat, wallabies and a range of bird life. The catchment is relatively inaccessible and is an area where vehicle access is controlled. There are several walking paths through the catchment, and camping is not permitted.

**Boggy Creek.** The Boggy Creek catchment is the northeast aspect of Mt Buller and is bounded by two spur lines running north (McLaughlan Shoulder and Burnt Hut Spur). The catchment is above 1,250m elevation and is mainly covered in snow during the snow season. During the snow season, the water sourced from the catchment is either snowmelt, or groundwater. During summer the majority of water is ground water.
