ANNUAL REPORT

2007-2008

DRINKING WATER SUPPLY

MT BULLER AND MT STIRLING

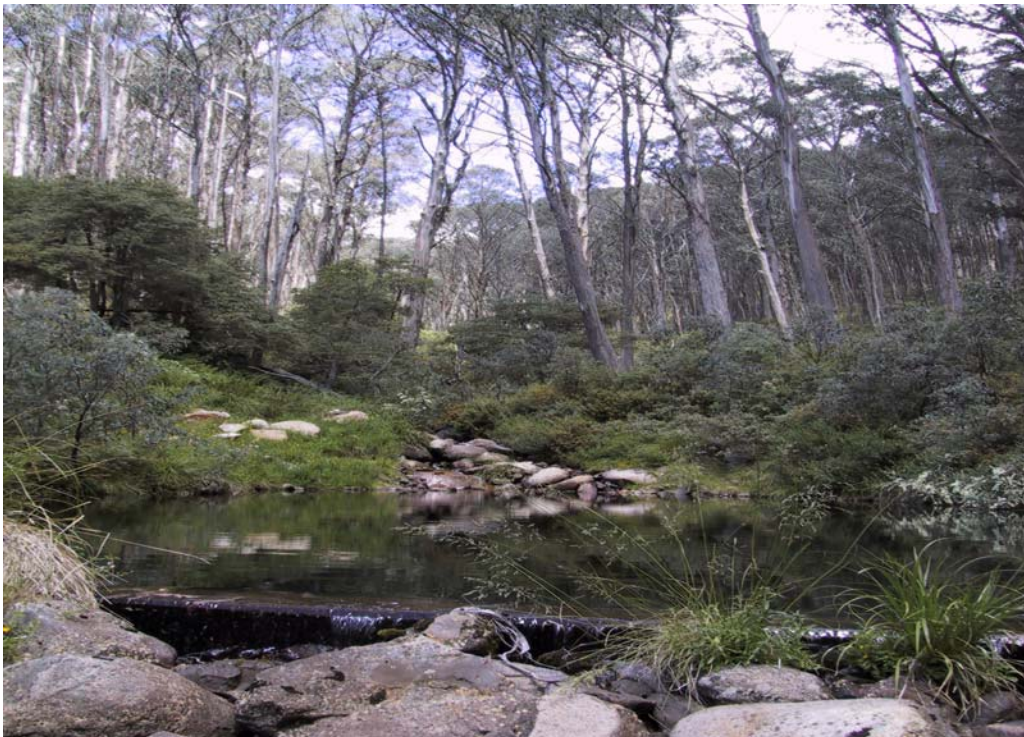
Picture 1. Boggy Creek catchment

**Boggy Creek.** The Boggy Creek catchment is the northeast aspect of Mt Buller and is bounded by two spur lines running north (McLaughlan Shoulder and Burnt Hut Spur). The catchment is above 1,250 m elevation and is mainly covered in snow during the snow season. During the snow season, the water sourced from the catchment is either snowmelt, or groundwater. During summer the majority of water is ground water. The picture below is a view up the catchment.

The picture above gives a good indication of the nature of the catchment from which the Mt Buller Alpine Village drinking water is sourced. The topography is steep and vegetated. The catchment lies in montane, sub alpine and alpine areas. There are few weeds or other exotic flora. Fauna consists of wild dogs, deer, wombat, wallabies and a range of bird life. The catchment is relatively inaccessible and is an area where vehicle access is controlled. There are several walking paths through the catchment. Camping is not permitted within the catchment.

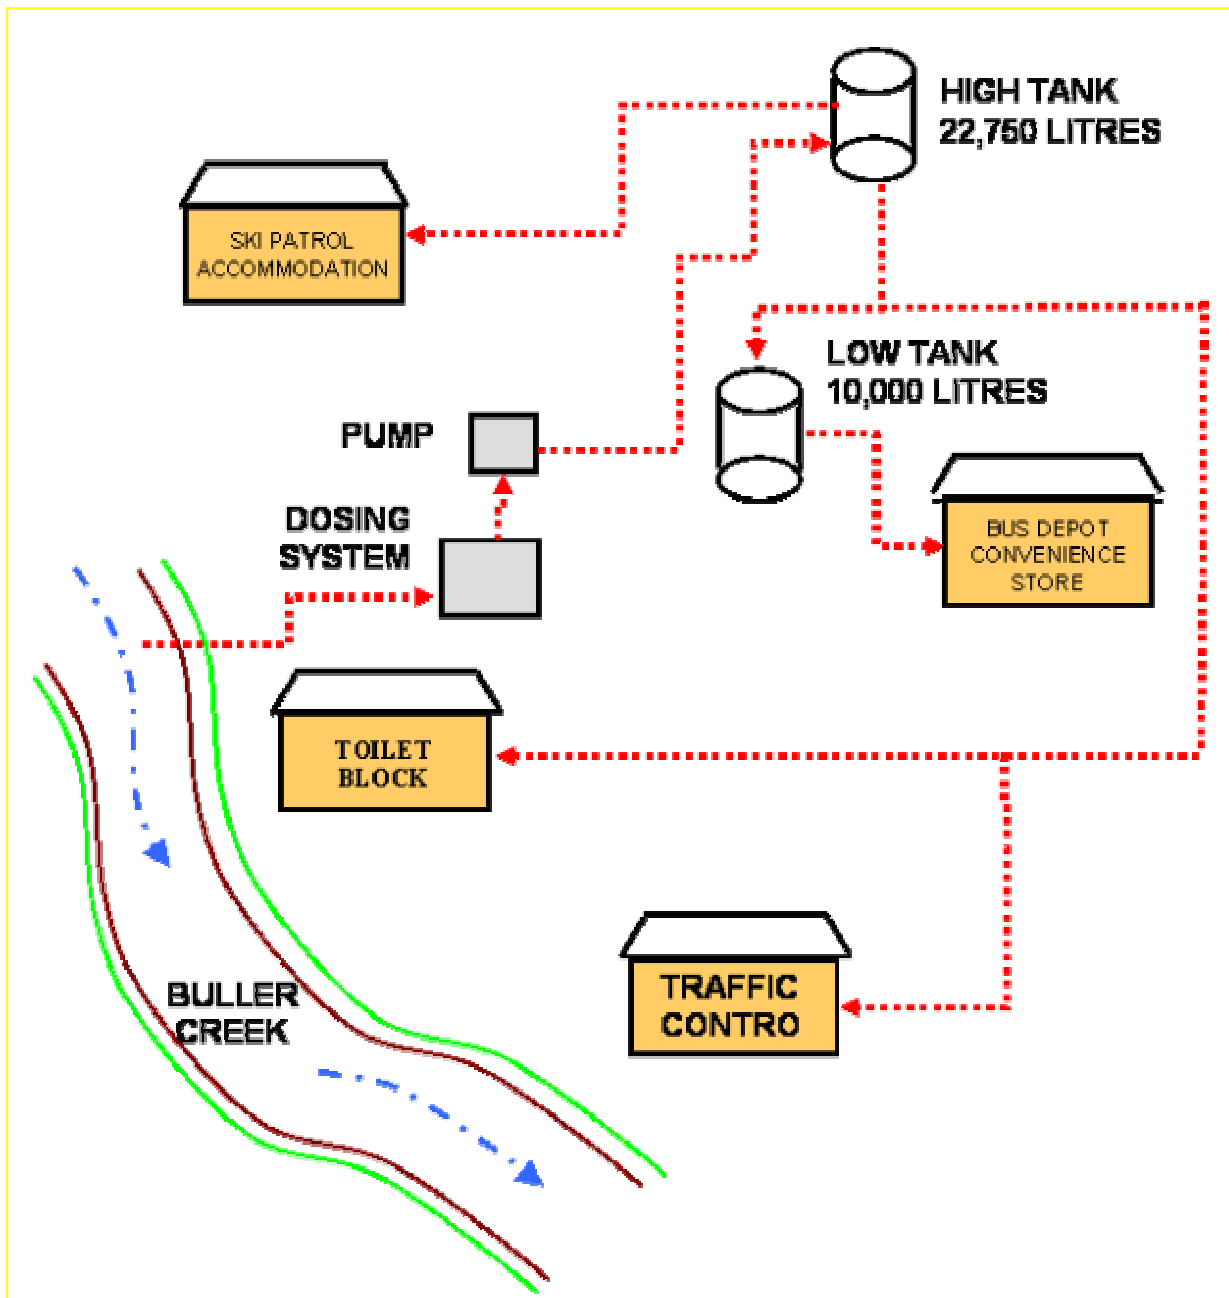
Schematic 2. Mirimbah Water System

The schematic below depicts the Mirimbah water supply.

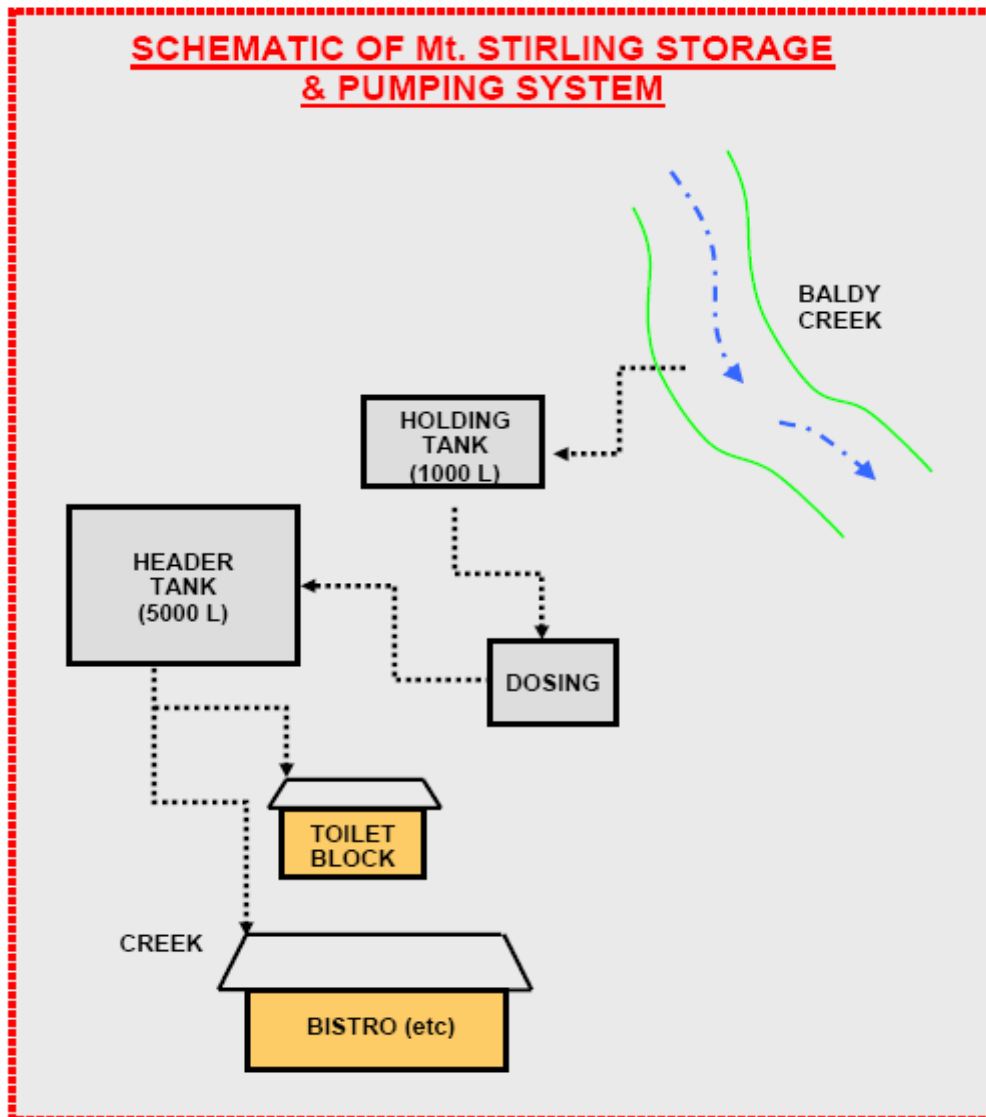
Schematic 3. TJB Water System

The schematic below depicts the TBJ water supply.
